MERRIMACK RIVER BASIN
STODDARD, NEW HAMPSHIRE

HIGHLAND LAKE SOUTH OUTLET

NH 00054

PHASE I INSPECTION REPORT
NATIONAL DAM INSPECTION PROGRAM

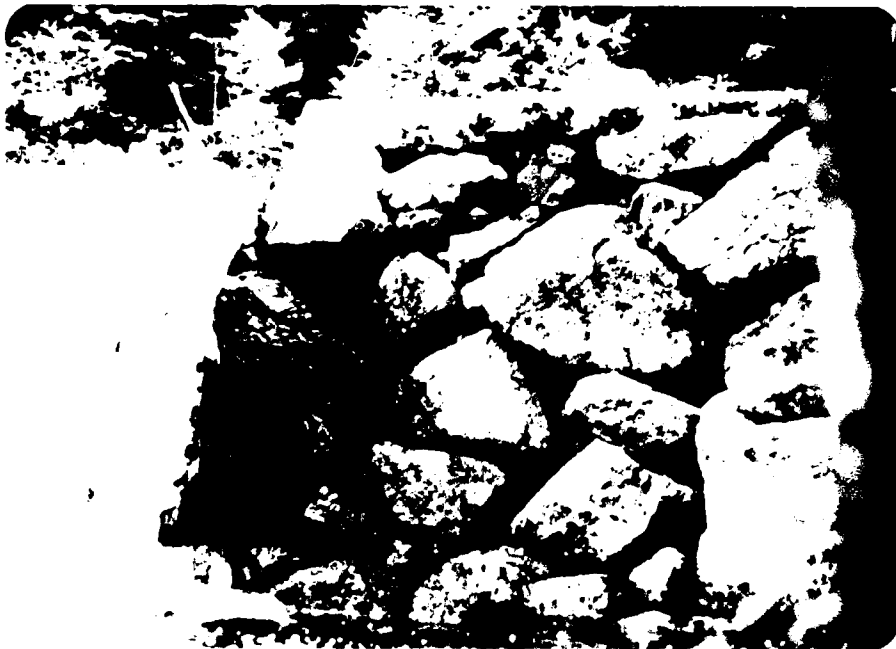
The dam contains an intermediate buttress constructed between the spillway and the sluiceway and founded on rock. This buttress consists of dry rubble stone masonry with concrete facing on the upstream side and its top surface. The downstream side of the buttress consists of rubble stone set on a near vertical plane. Portions of this masonry directly under the surface slab are missing, as is stone at the base of the rubble. The top concrete surface shows evidence of erosion and contains spalls and wide random cracks. Grass flourishes in the cracks.

7. View of buttress from right side downstream

- (1) Seal all joints and cracks and maintain them free of debris and vegetation.
- (2) Repair all areas of spalled and eroded concrete.
- (3) Pack all voids in the downstream dry rubble stone masonry by guniting, or by other suitable techniques, to prevent the loss of additional material.
- (4) Decrease the response time in opening the outlet works in an emergency. The NHWRB should consider delegating some operational responsibility to a local official such as the police or fire chief. This individual or his delegate would maintain a set of keys to the stop-logs for use in an emergency as directed by the NHWRB.

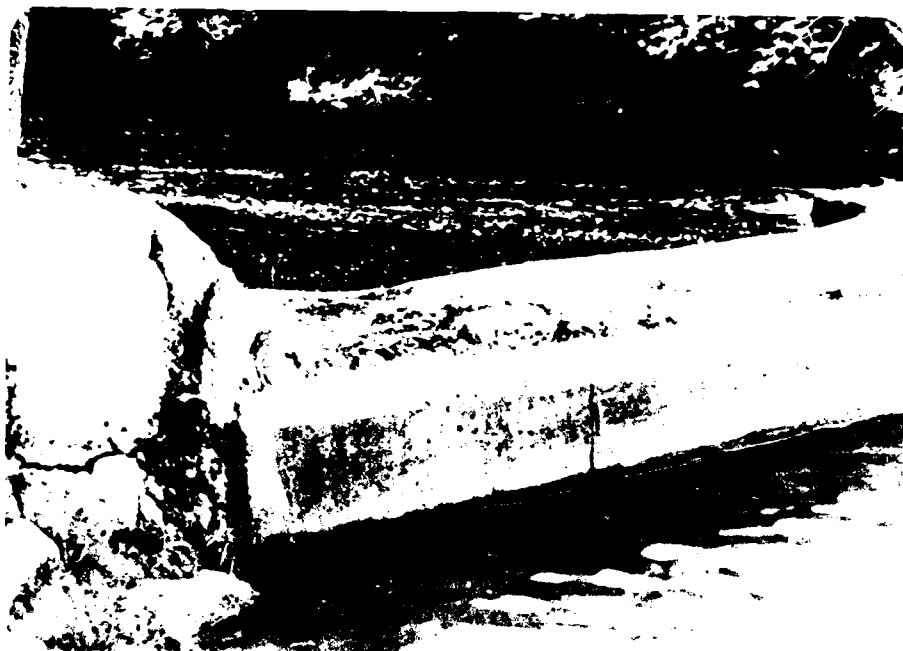
5. View from upstream of left abutment

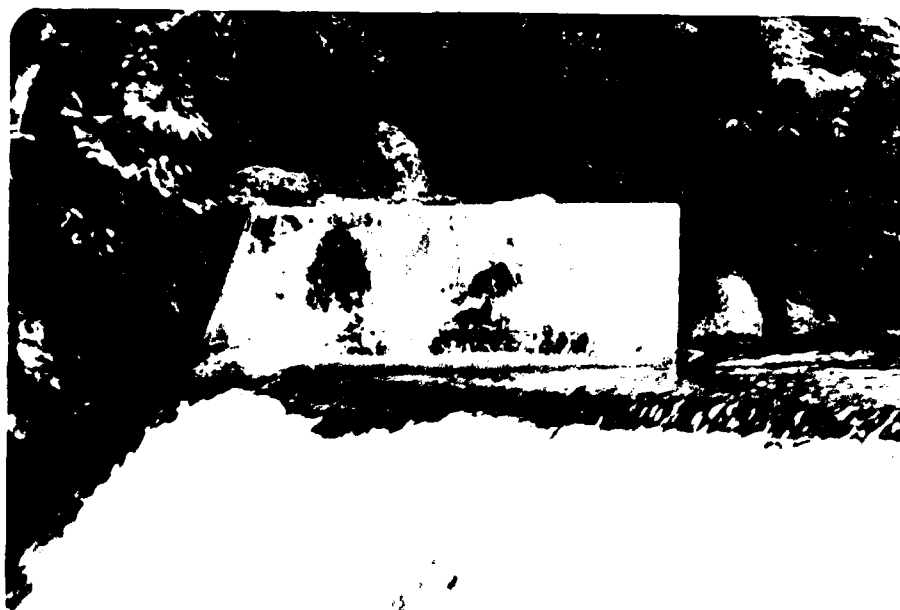
The west abutment, which is approximately 15 feet long and 12 feet wide, is similar in construction to the spillway. Medium random cracks and efflorescence are prevalent on the vertical surfaces of the concrete portion of the abutment. The exposed downstream rubble wall face does not show any sign of displacement. This abutment ties into detached bedrock.

6. View from downstream of right abutment

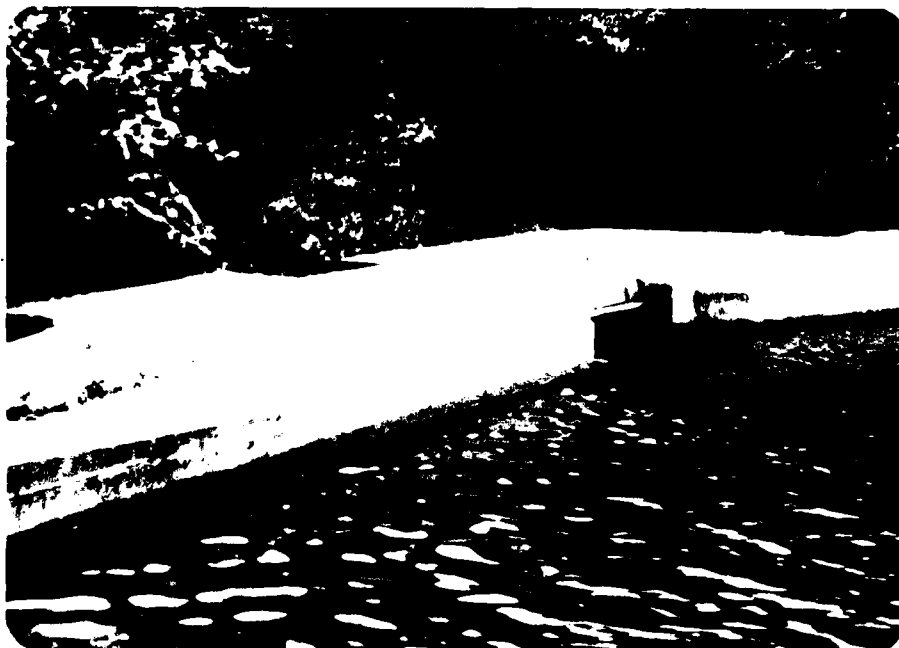
4. View from upstream of left abutment, buttress and sluiceway
